**REPORT OF THE TECHNICAL EVALUATION
OF THE
WEST ST. PAUL SWIMMING POOL
WEST ST. PAUL, MINNESOTA
2/7/25**

Burbach Aquatics, Inc. (BAI) respectfully submits this Report regarding the technical evaluation of the West Saint Paul Municipal Swimming Pool located in West St. Paul, Minnesota. This document is the final work product and report for professional services performed by BAI as per the Professional Services Agreement between BAI and the City of West St. Paul for Phase I-Step #1 Service.

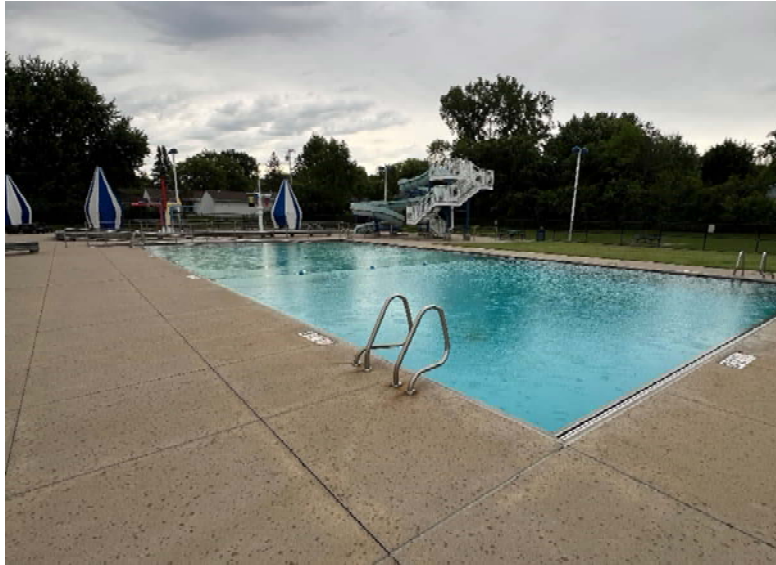
Main Pool Vessel

However, the both pools are losing significant water during operation. No significant cracks are reflected through the finish. It can be assumed that replacing the finish with a new finish along with spot concrete repair would extend the life of the pool. If the aggregate finish is original to 1999 the city got more than the typical life for an aggregate finish for the Minnesota climate. Both the lap pool and splash pool surge tanks are suspect of being a source for pool water loss based on staff reports. The surge tank which manages the effective surge of the lap pool during patron use is of original construction, predating the renovation project in 1999. In addition to its condition the tank is also undersized to meet the capacity required per code. Deck areas south of the lap pool vessel are having issues of settlement, which is apparent by the grouted mud jacking bores and hollow sounding sections.

- b. Ground water does not appear to be an issue.
- c. Complete assessment of the pool vessels concrete condition was incomplete. For this reason BAI recommends the removal of the poor aggregate pool finish. This will give a better opportunity to visually observe the vessels concrete. While the pool finish is removed BAI recommends to test the integrity of the vessel with a leak test.

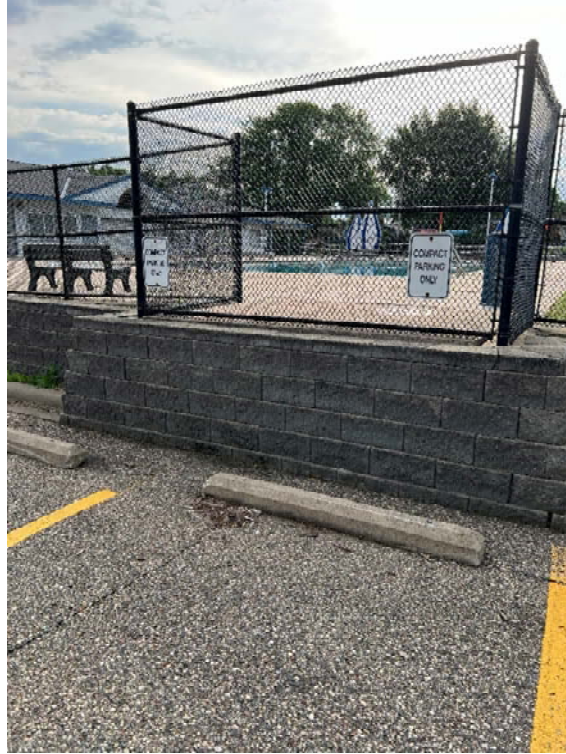
Facility Site Enclosure and Foundation Wall

3. Pool Enclosure (Fence)
- a. The chain-link enclosure is in great condition.
 - b. Site conditions have affected the stability of the perimeter mow-strip and post footings. Skewed fence posts specifically at the fence terminations have created gaps larger than 4 inches within the site enclosure.

- c. BAI recommends re-stabilizing the misaligned fence posts to resolve the gaps. Re-using the existing chain link pool enclosure is recommended as long as a renovation project maintains the existing boundary.

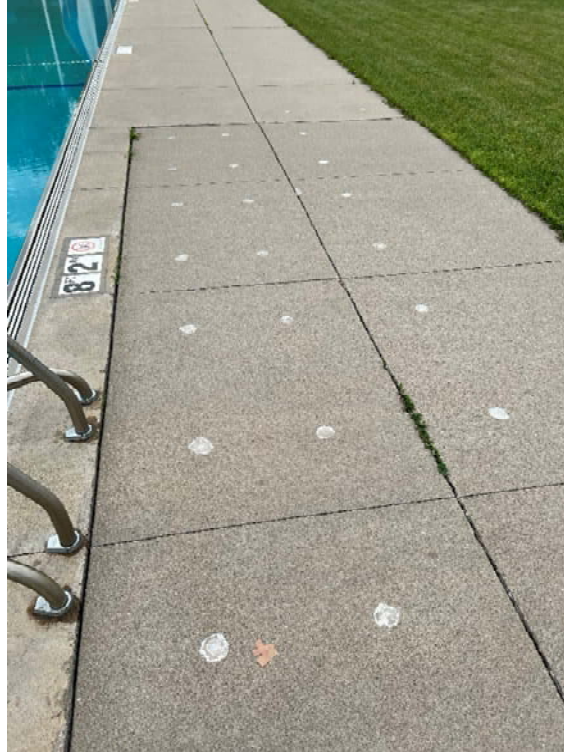
Deck Area Which Underwent Mud Jacking

- a. The majority of the deck surface is in decent condition with select areas experiencing cracking.
- b. A large problem area is occurring on the south side of the main pool vessel. Along a majority of the south pool wall and extending roughly 5 feet, the deck is hollow sounding. Several grouted drill locations are found along this area where apparent concrete jacking has occurred.
- c. With a 25-year design life renovation project, which maintains the existing pool vessel. BAI recommends the hollow sounding deck areas be removed to review the soil settlement condition and its cause.
- d. With a 50 year design life replacement project, which replaces the existing pool vessels. BAI recommends replacing a majority of the deck area as much of it will be removed for a large scale construction project. This is included in the Opinion

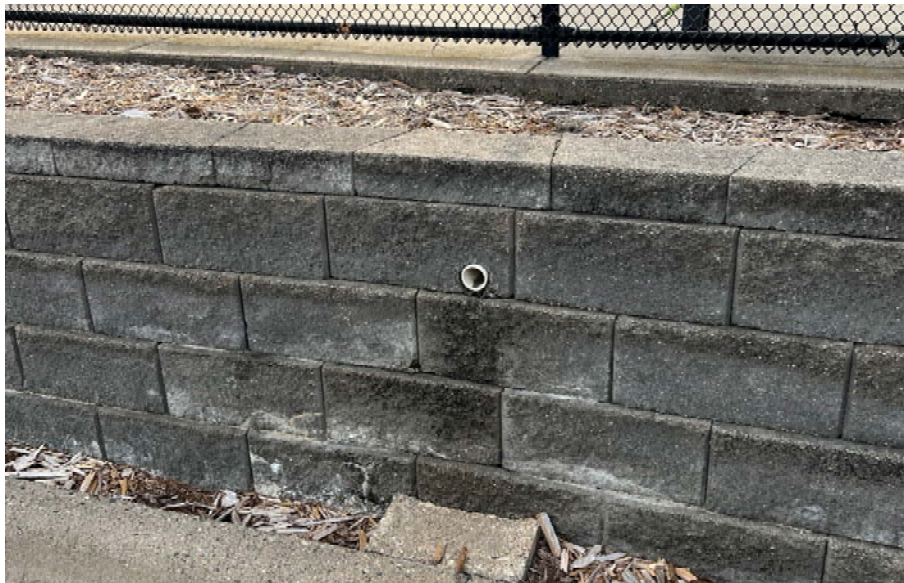
Deck Drain Outfall

- a. The deck drain system should be sufficient for total pool deck drainage. However, the trench style drains are clogged to the point minimal rain water reaches the discharge locations in the parking lot retaining walls. Water ponding on the deck surface is a direct result.
- b. Removing the debris from the trench troughs should resolve this issue and should be added to routine maintenance practices.
- c. Staff mentioned the brittle condition of the pool deck drains makes it difficult to remove the grates and clear debris.
- d. For a 25 year design life BAI recommends the existing trench drains be cut and removed with new trench drains installed in their place.
- e. With a 50 year design life and complete deck replacement recommended, the deck drain system should also be replaced. This is included in the Opinion of Probable Construction Cost.

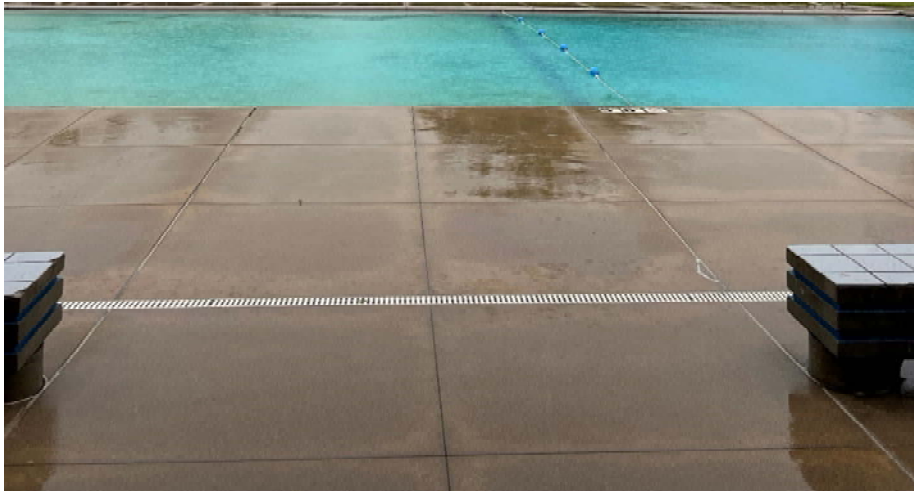
Deck Trench Drain Experiencing Flooded Condition

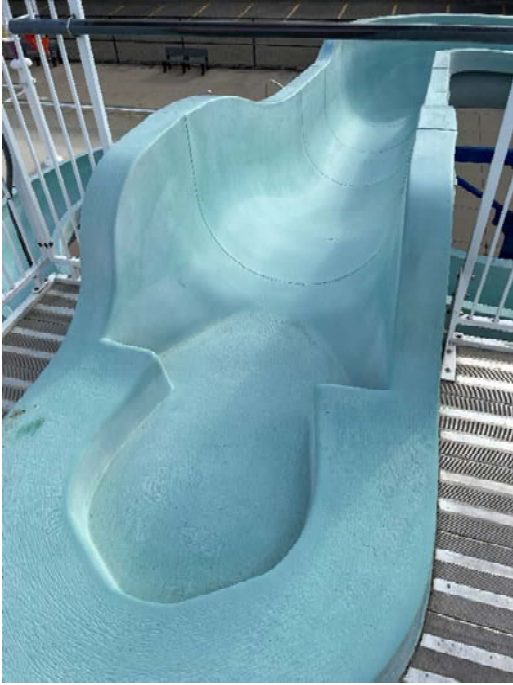
- iv. The composite fiberglass slide flume is fading from UV exposure.
 - v. BAI recommends the slide be rehabilitated to bring back to near new condition. This would include new foundations, replacement of rusted components, and flume restoration. The city has been in contact with a slide restorer and has received quotes.

Faded Water Slide Flume

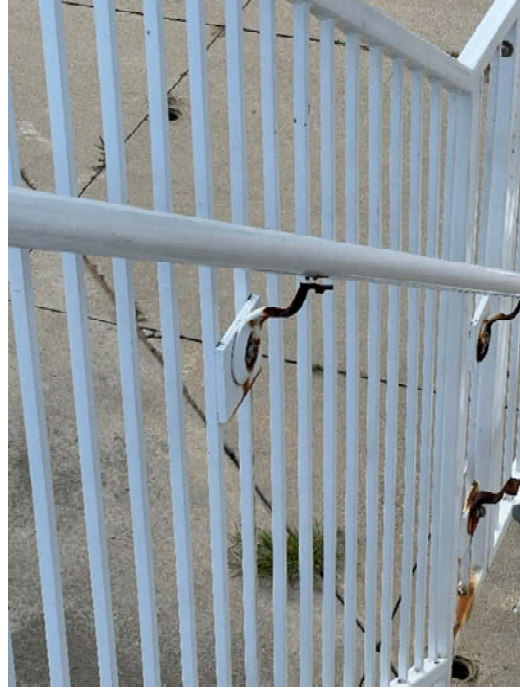
- iii. Supports for the stairway railing are highly corroded and in some cases sheared off due to the deteriorated condition. Left unrepaired, the railings will fall off from their supports.

Rusted Railing Brackets

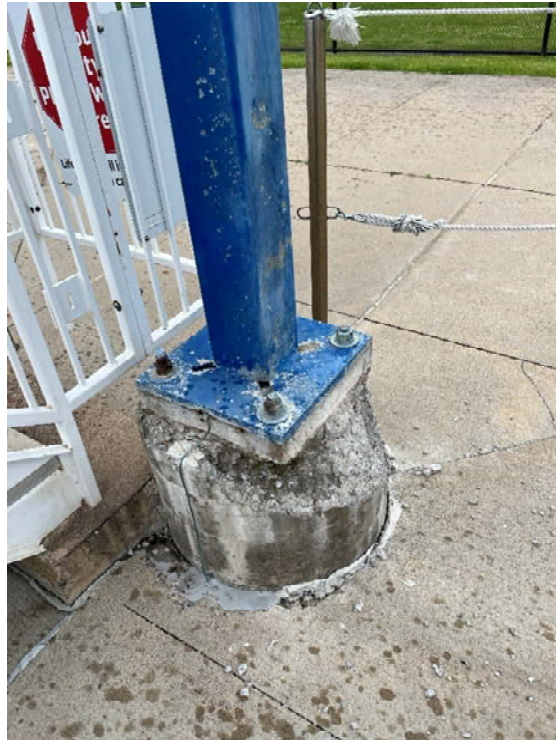
- i. The pool slide's foundations are in poor condition. Several of the concrete foundation columns are experiencing spalling failures. These failures compromise stability of the structure, especially if the condition is worsened.

Failing Slide Foundations

- ii. The foundations with advanced deterioration should be called out as needed to be rebuilt. The slide should not be placed in service until the foundations have been repaired.

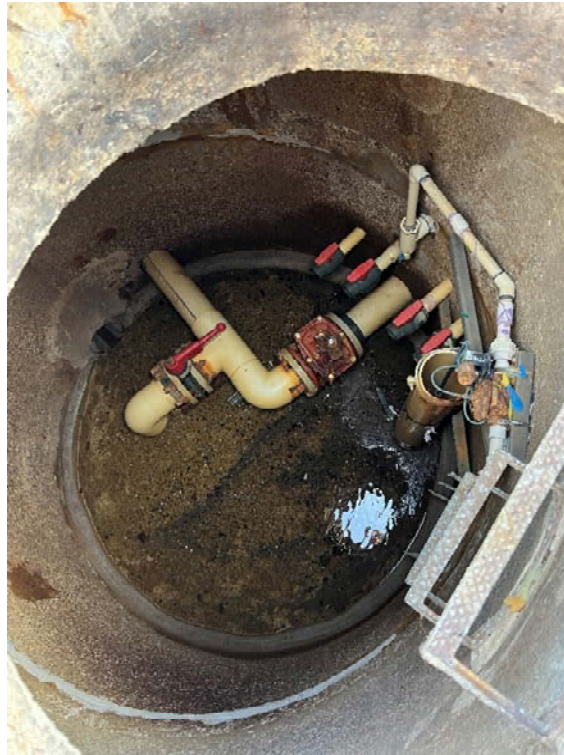
Interior of Pool Surge Tank

- a. The surge tank vessel used for the main pool is original construction from the previous pool vessel. The tank also doubles as a collection vessel for pool winterization.
- b. Staff reports the surge tank is leaking. Which is likely the case due to its age.
- c. Based on field measurements the main pool's surge tank is well below the one gallon of surge capacity per square foot of surface area requirement.

- d. Due to its condition, reported water loss, and being undersized BAI recommends the replacement of the existing surge tank with a new tank of sufficient sizing. This cost is included in the Opinion of Probable Construction Cost.
- e. For a renovation project with a 25 year design life the existing surge tank can remain in its role for pool drainage and winterization. With a 50 year design life and new pool vessel a deep manhole should be constructed to handle pool underdrainage and winterization.
- f. The splash pool has a separate surge tank which is size appropriately and in good condition.

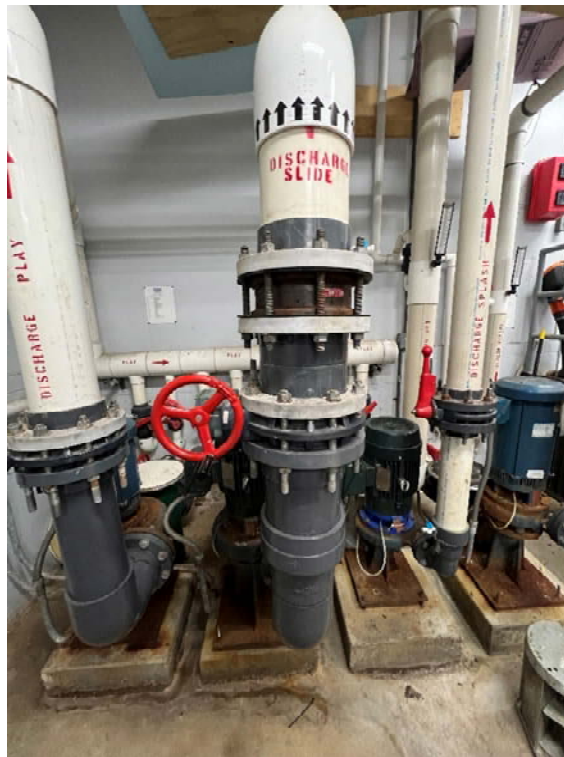
Facility Recirculation Pump Array

- a. The lap pool recirculation pump is a Pentair Aurora 342A 4x5x9A which is the same brand and model installed with construction in 99'.
- b. Based on the level of corrosion of the pump housing it appears the unit has severed the full 25 years without replacement.
- c. Although properly sized the condition of the recirculation pump drives BAIs recommendation to replace the existing unit with one of the same make and model. This cost is included in the 25 year design life Opinion of Probable Construction Cost.
- d. For a 50 year design life the pump should be replace with a model that meets the recirculation requirements of a new pool vessel.

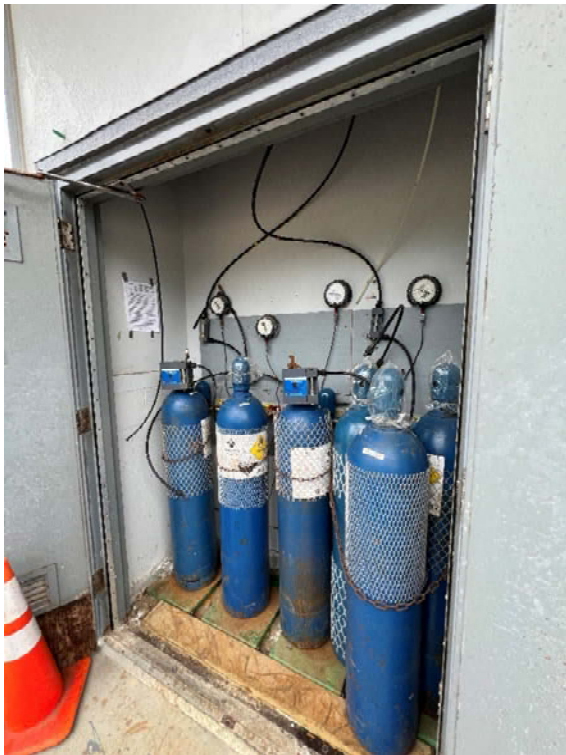
Gas Chlorine Cylinders and Storage Room

- ii. The number of facilities using gas chlorine has reduced due to high maintenance costs, insurance costs, and additional operator training associated with a gas chlorine system.
- iii. For these reasons BAI recommends switching to a liquid chlorine injection system. The switch should be fairly seamless and low cost. This is included in the Opinion of Probable Construction Cost.

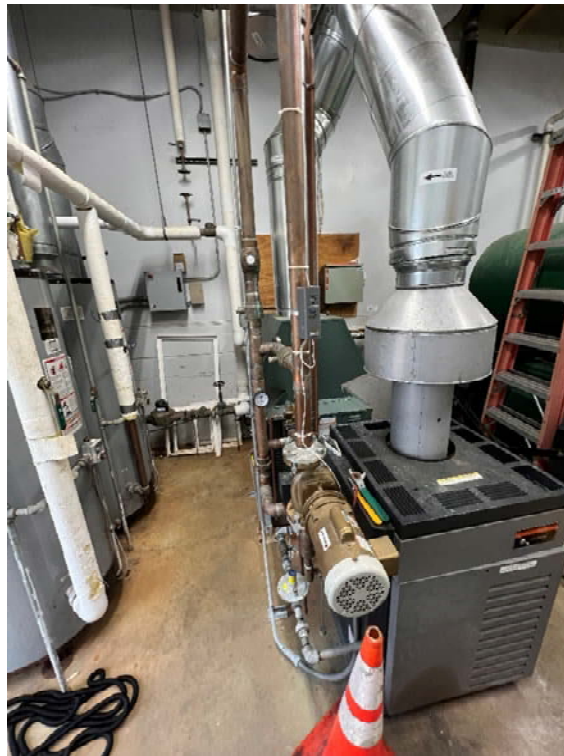
Domestic Water Heaters (Left) Pool Heaters (Right)

- a. The pool heaters are both Raypak brand. The smaller of the heaters which serves the splash pool vessel is completely inoperable. The other heater is of a similar age and should be replaced prior to its failure.
- b. For both a 25 and 50 year design life BAI recommends new pool heaters. Newer pool heaters offer much greater efficiency in a smaller footprint. In addition to maintaining pool water heating, energy savings, and floor space can positively affect the facility. This cost is included in the Opinion of Probable Construction Cost.

- a. Two potable water heaters are used in parallel to supply hot water to the facility. Fixtures use mixing valves to temper bathroom water temperature.
- b. Both are in good condition and no work is needed.

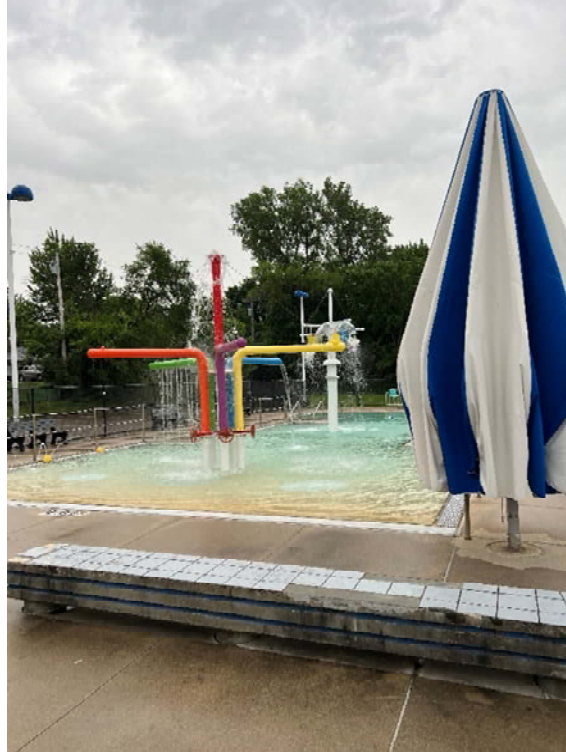
Do Pools Leak Water Y N Amount 18"/ Day in the Splash Pool

- e. BAI recommends a complete assessment of the pool vessel concrete. This would include removal of the existing exposed aggregate for visual observation followed by a leak test.
- f. Contemporary concrete surface repair methods are available and shall be used if necessary for a 25 year design life.
- g. For a 50 year design life BAI recommends the replacement of the pool vessel into a separate similarly sized pool vessel or else realized within a large single vessel to maintain the pool surface area at the facility.

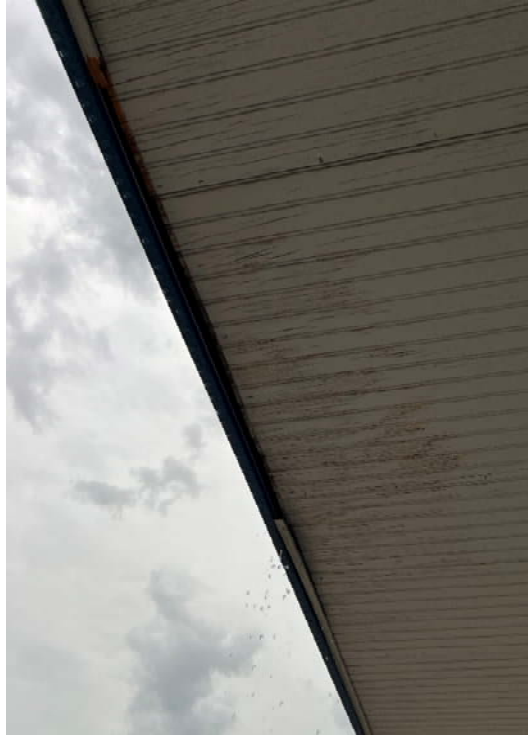
1. There were no signs of leaks within the bathhouse. Heavy rain was occurring during observation.
2. The beaded plywood used as soffit material is beginning to deteriorate. It appears the lack of a rain gutters with the drip edge roof design is allowing the collection of water under the roof's eave. (See image below)

Bathhouse Eave Condition

- d. There is a cost included in both Opinions of Probable Construction Cost for repairing the underside of the roof eave where deterioration is occurring.

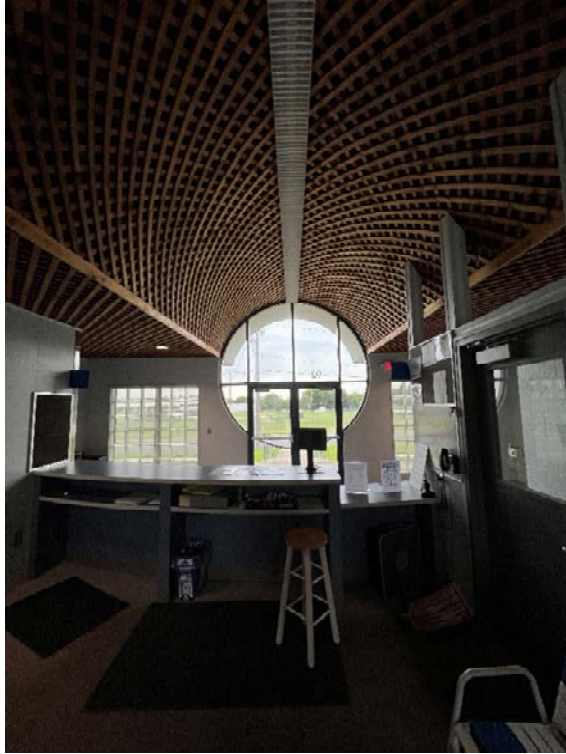
Interior Ceiling Façade Showcasing the Front Window and Door Assembly

- a. No cost is included at this time for the bathroom doors or windows.
- b. An eye should be kept on the corrosion select doors are experiencing and replaced when necessary.

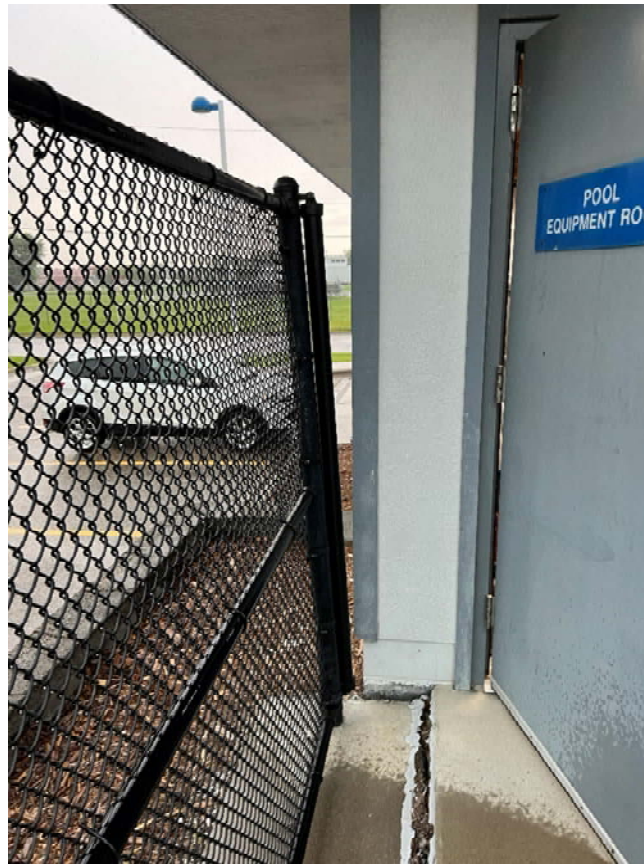
- a. The site pad is built up roughly 4'6" relative to the facility parking lots. The pool deck area is stabilized via retaining walls where needed.
- b. The retaining walls are in decent condition with no apparent failures. However, erosion of the granular material between the retaining walls and pool deck has caused movement of the perimeter mow strip and in some cases the fence post footings.

1. Erosion of the granular material between the site retaining wall and 2' wide mow strip has caused movement of the mow strip and fence post footings.
 - a. The retaining wall appears unaffected.
 - b. Movement of the fence footings has created a gap greater than 4" at the fence termination.

Failing Mow Strip and Fence Footings

- c. BAI recommends with a renovation project, the mow strip and fence post footings be reoriented and stabilized with compaction of the granular material behind the retaining walls. This work is included in the Opinion of Probable Construction Cost.
- d. The existing site enclosure, bathhouse, parking lots, and site pad can be reused with a renovation project.

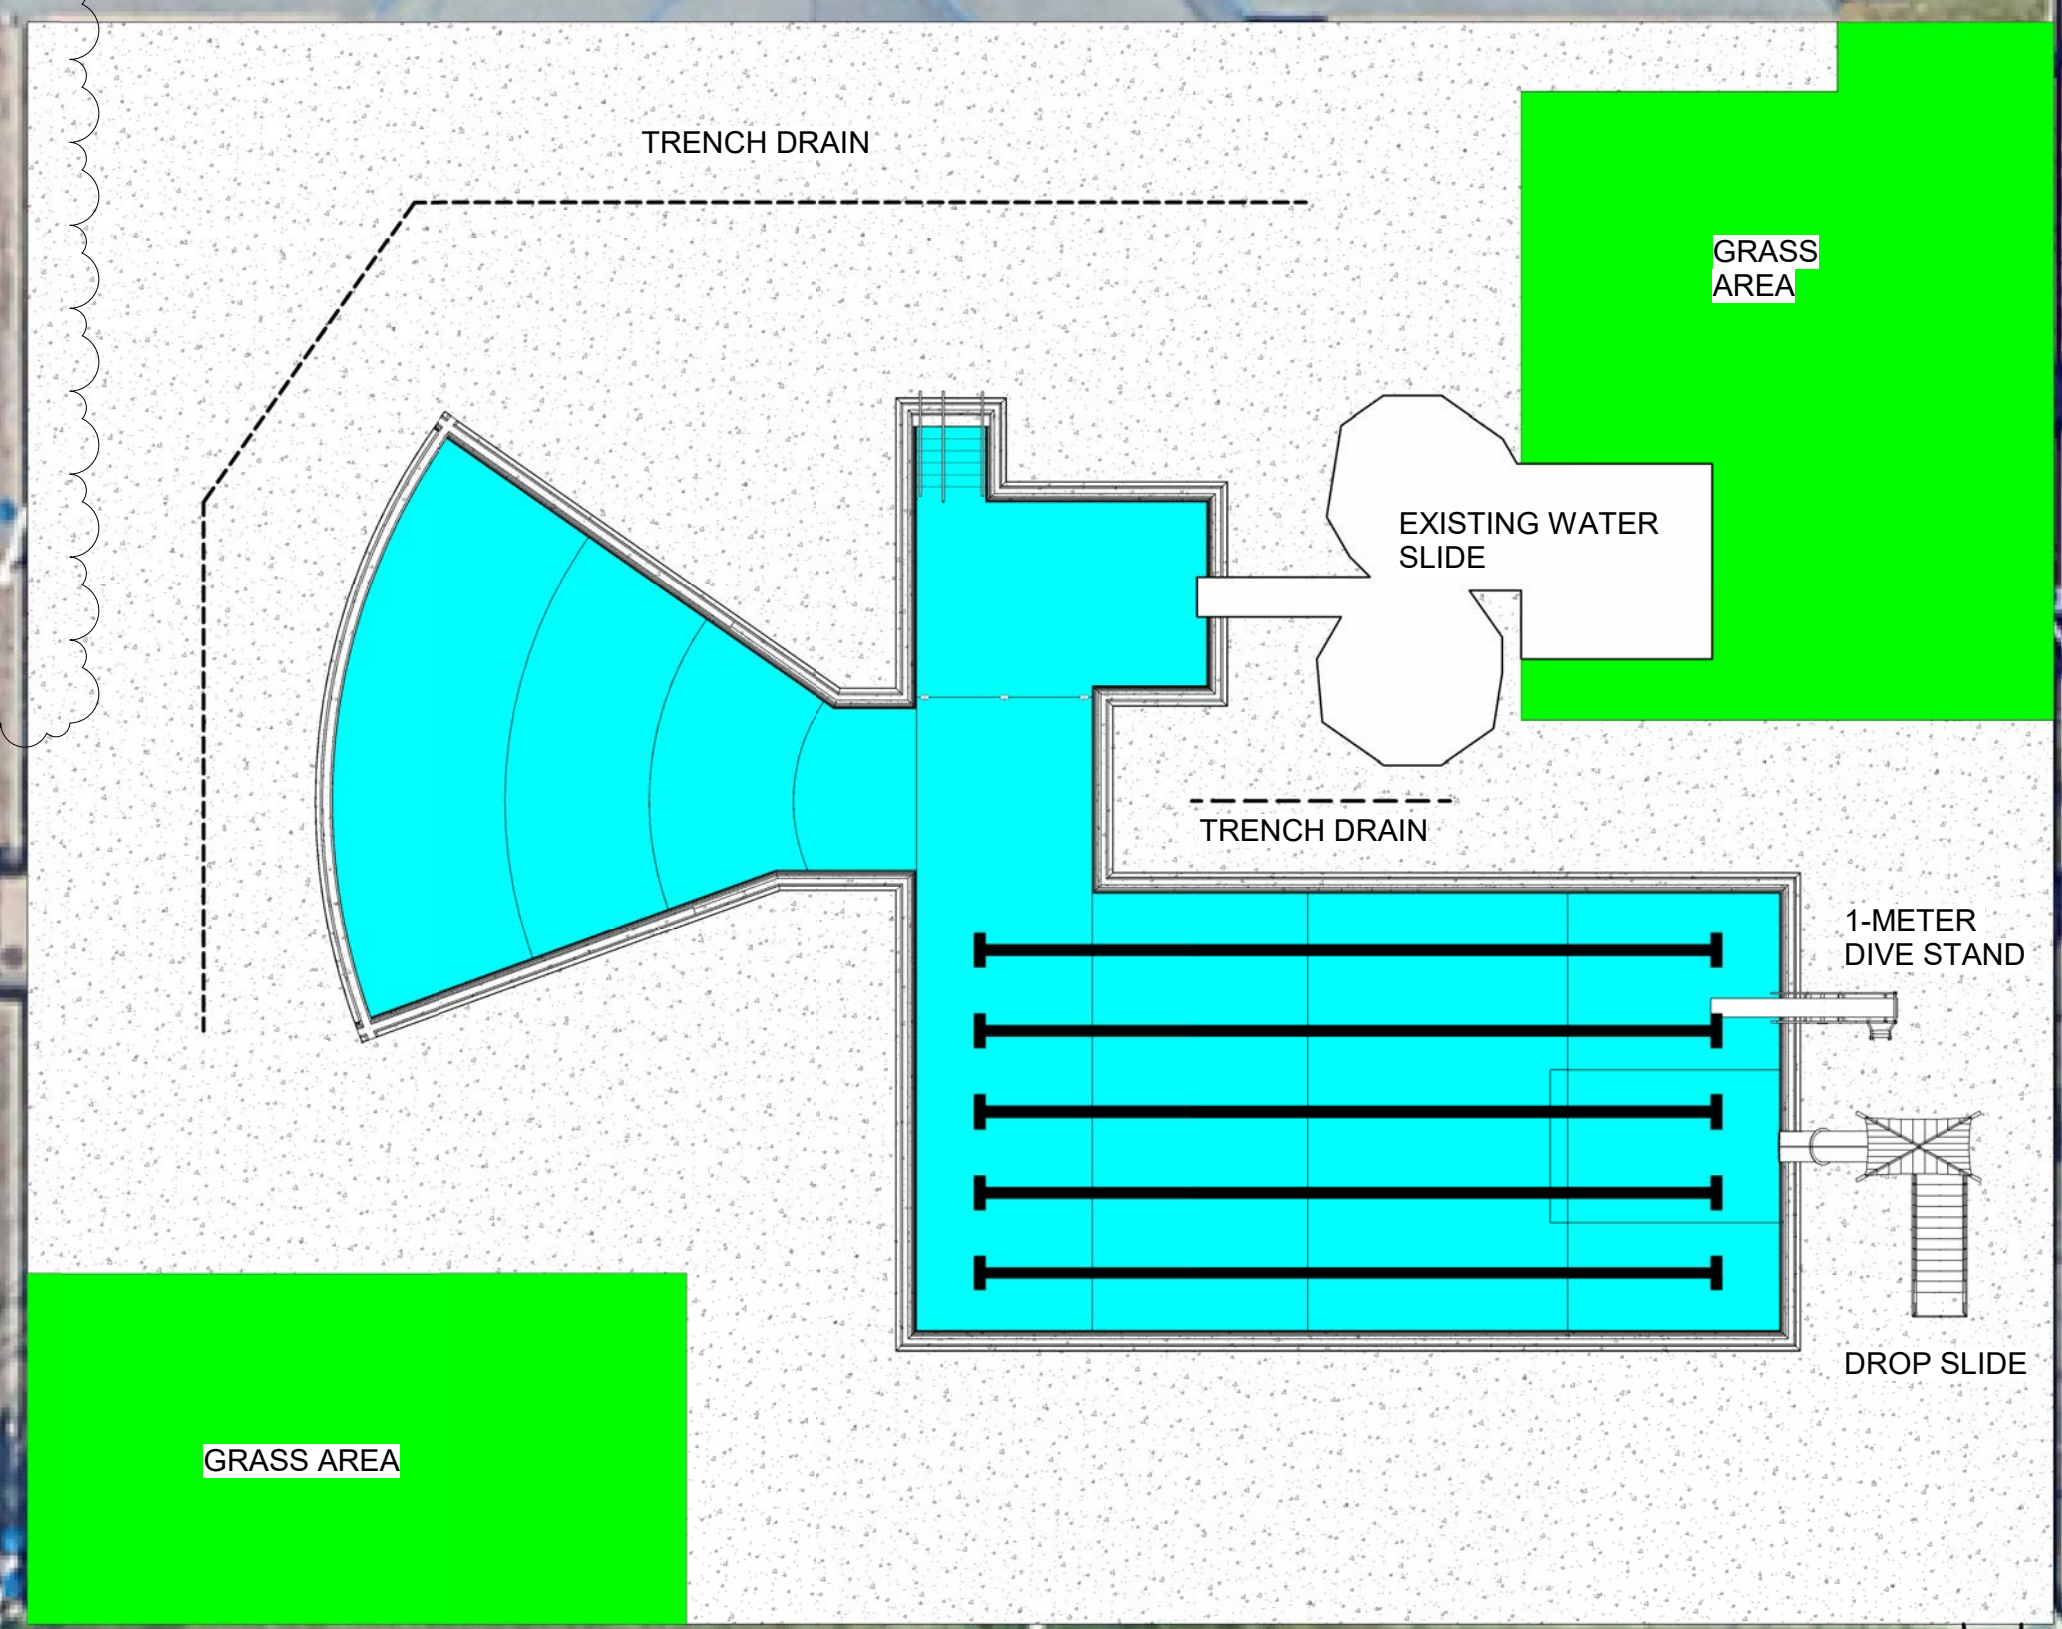
AREA NEEDING RE-STABILIZATION FOR FENCE REPAIR

NEW EMERGENCY EXIT GATE (1/2)
